**SOUHEGAN RIVER WATERSHED  
DAM NO. 26**

**NH 00207**

**PHASE I INSPECTION REPORT  
NATIONAL DAM INSPECTION PROGRAM**

**AUGUST 1979**

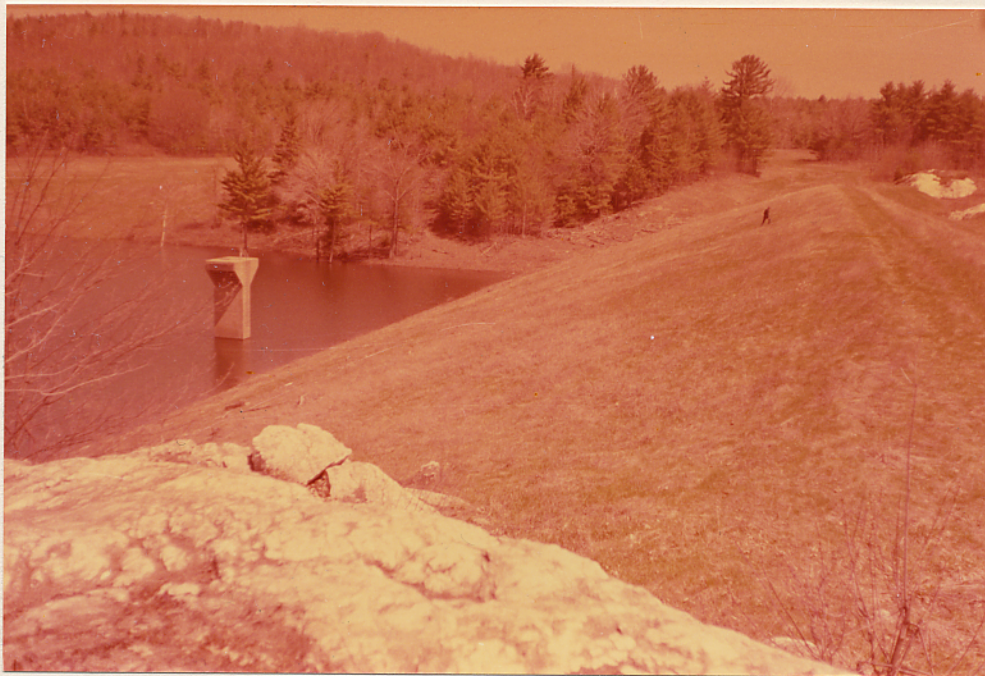
Overview from right abutment

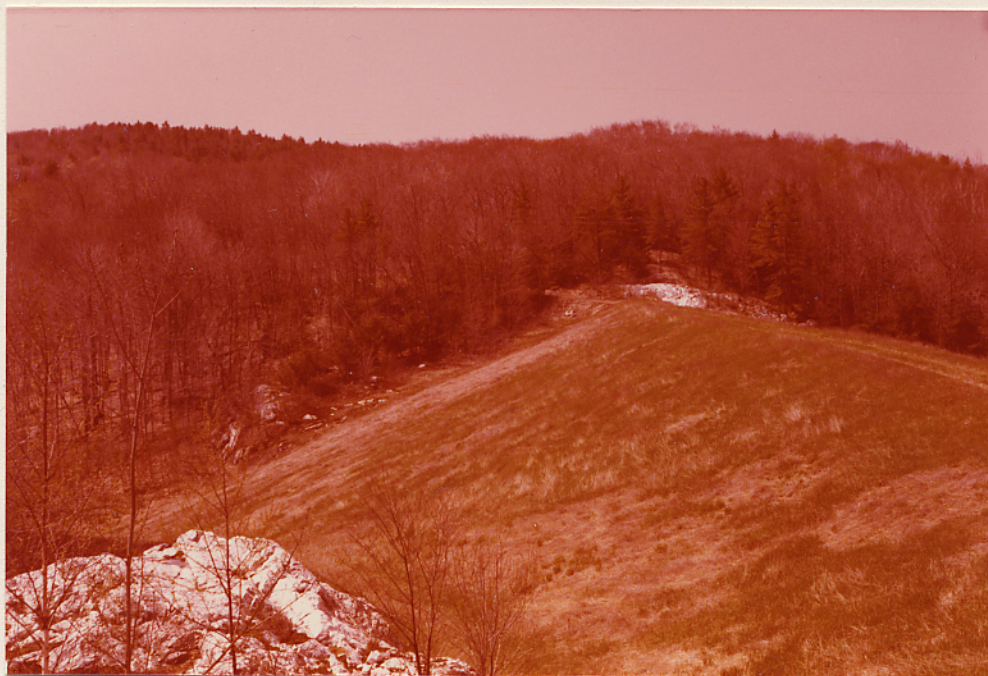
Overview from left abutment

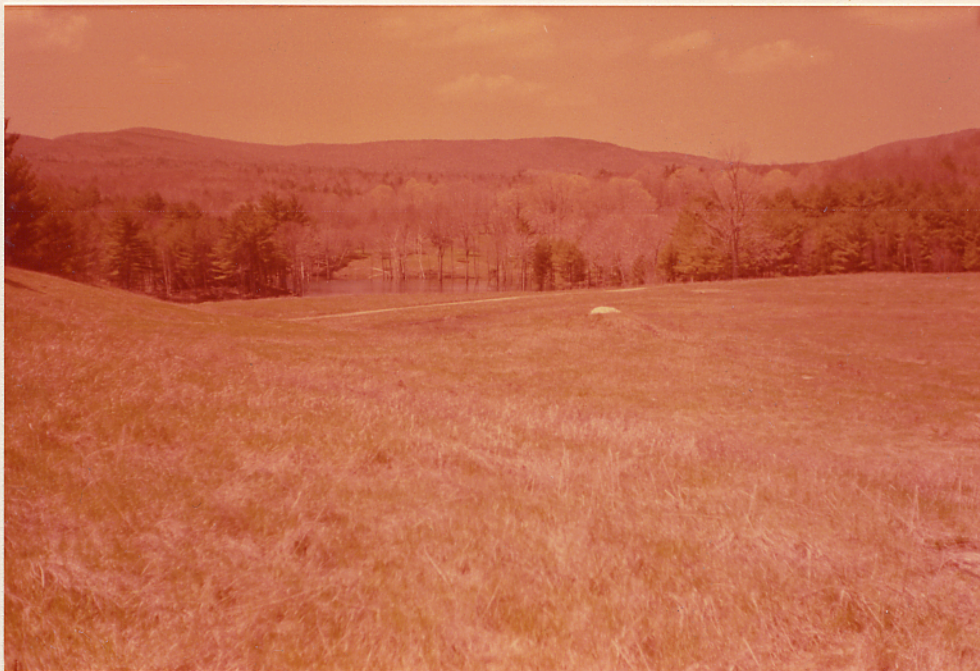
The emergency spillway is in good condition. There are wet spots in the channel but these are caused by natural groundwater or ponded runoff.

1. View of emergency spillway channel  
looking upstream to pond

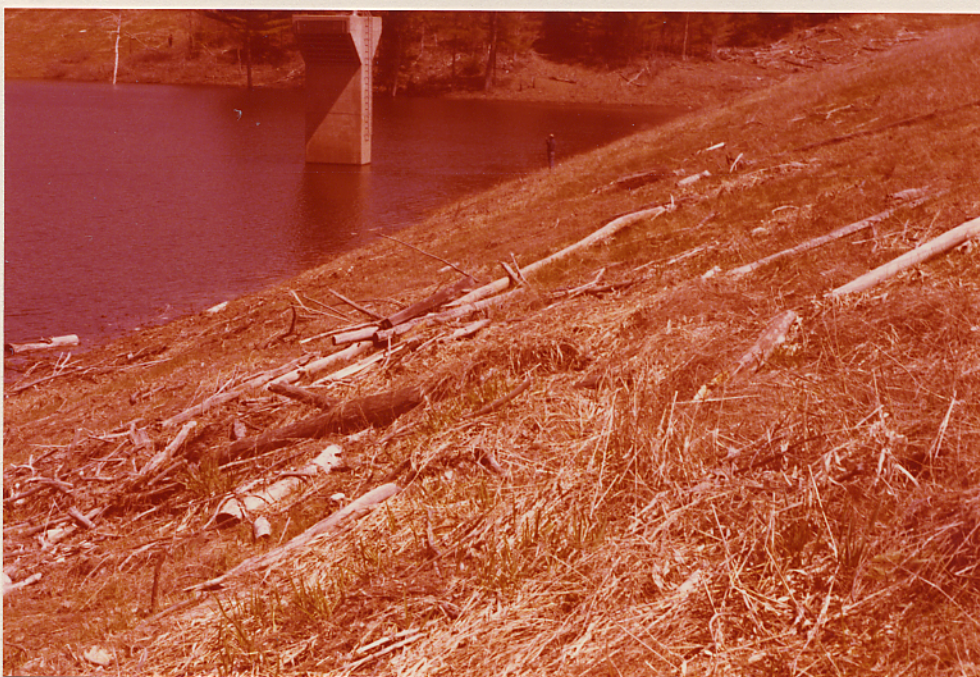
Two small animal burrows were found in the upstream slope. Tire ruts 4 to 6 inches deep and a drainage gully 6 to 10 inches deep were found in the right upstream toe of the embankment near the abutment. There is a foot path on the right downstream abutment. The upstream slope is not protected by riprap, but it is in good condition. There is debris on the upstream slope.

2. View of upstream slope showing drop  
inlet structure and debris on slope

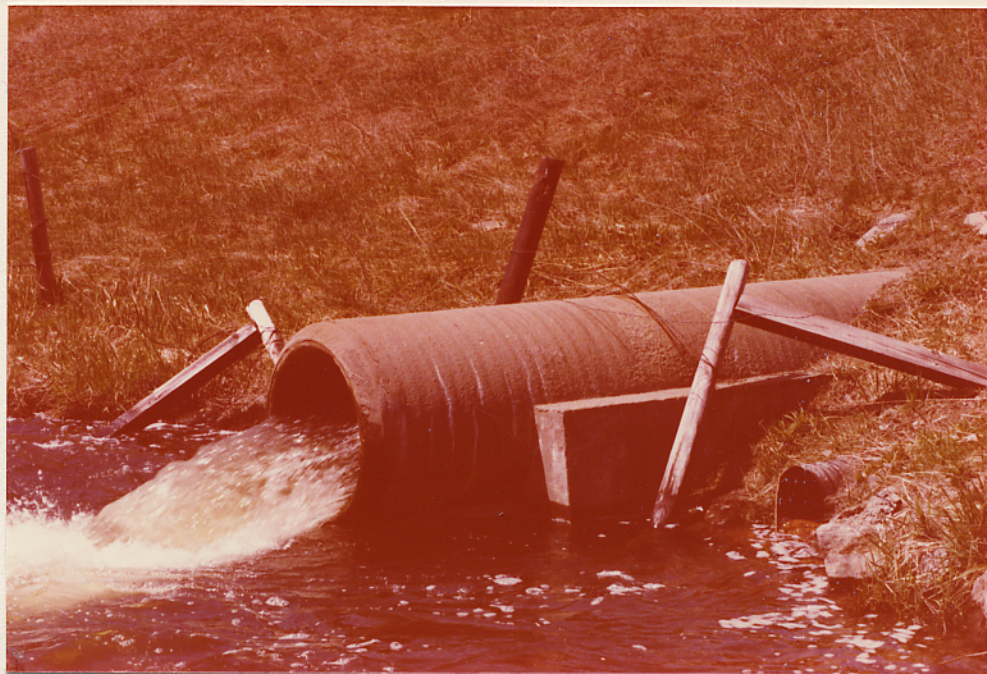
The downstream end of the outlet pipe shows cracking with associated efflorescence over 5 to 10 percent of its exposed surface. These cracks are from shrinkage and lack of quality control during construction. There is no evidence of settlement or displacement of the conduit. The tee bent is completely below ground.

3. View of outlet pipe showing efflorescence and left toe drain outlet

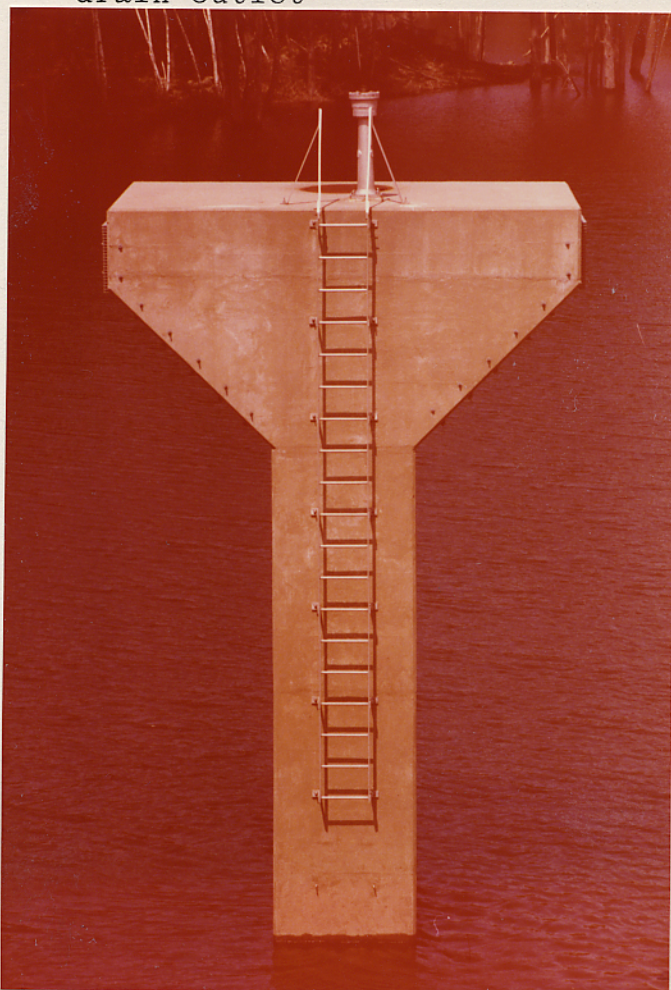
This structure was observed from the embankment since access to the structure was not possible. The existing ladder is too short and no extension was available.

4. View of drop inlet structure from embankment

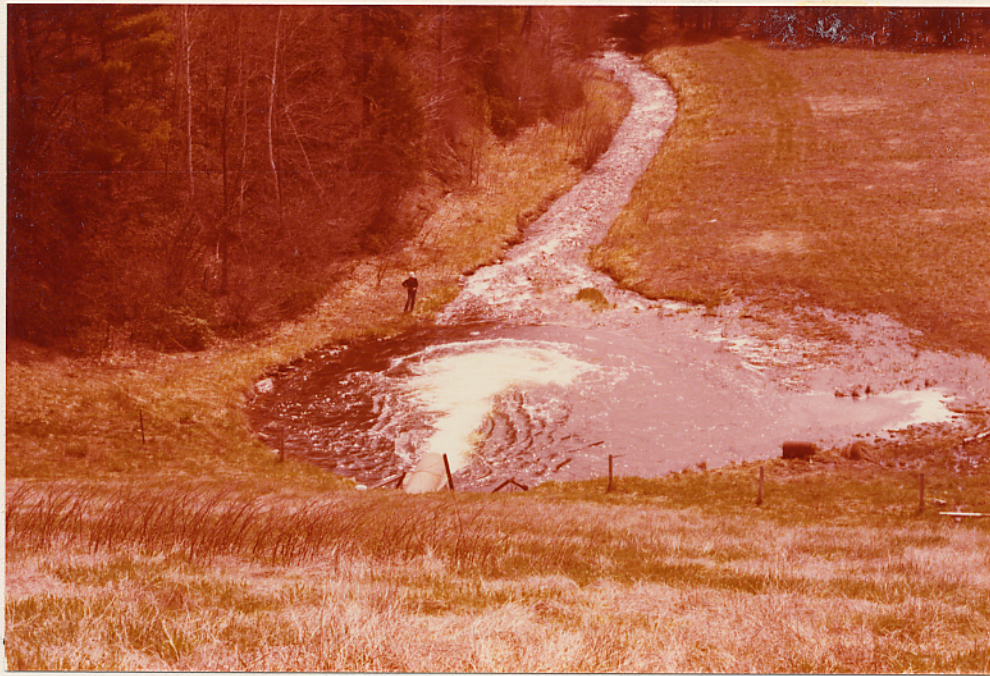
The downstream channel is a narrow channel passing over relatively flat flood plain. The channel appears stable and in good condition. Riprap protection of the plunge pool is in good condition.

5. View of downstream channel and plunge pool

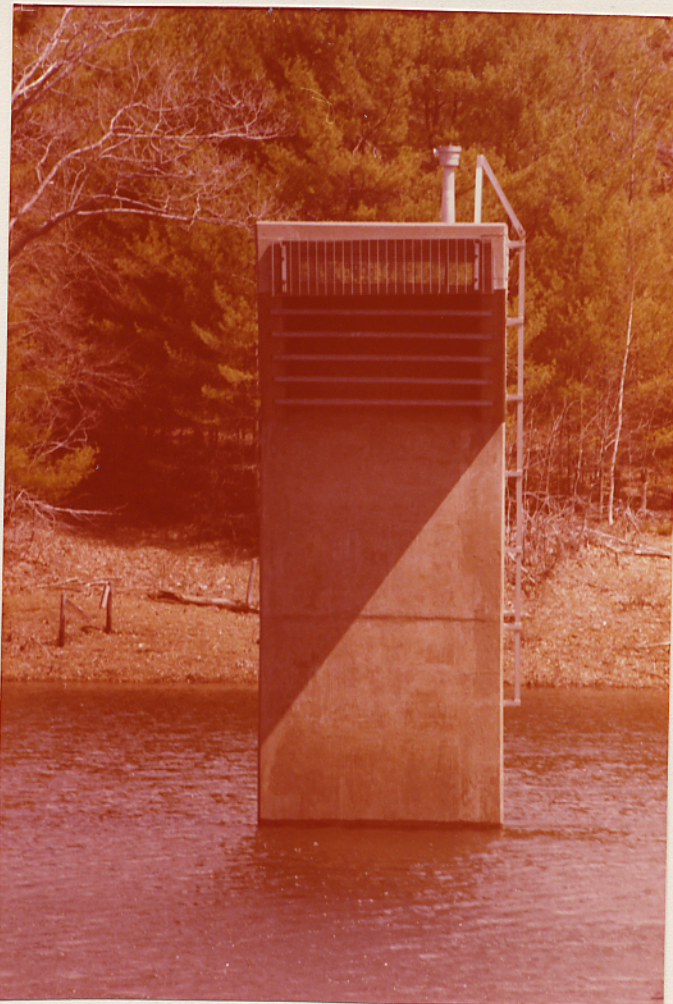
The structure is in good condition with no evidence of spalling, cracking, or efflorescence. The mortar rubbed surface finish has been worn away by moisture intrusion. The sluice gate bench stand is in good condition. The hand wheel has been removed from the site to prevent unauthorized use. The trash racks are in good condition but are clogged with debris. The exterior ladder is too short to allow access to the structure.

6. View of drop inlet structure showing trash racks
